Report of Summer 2021 Curb Ramp Field Data Collection

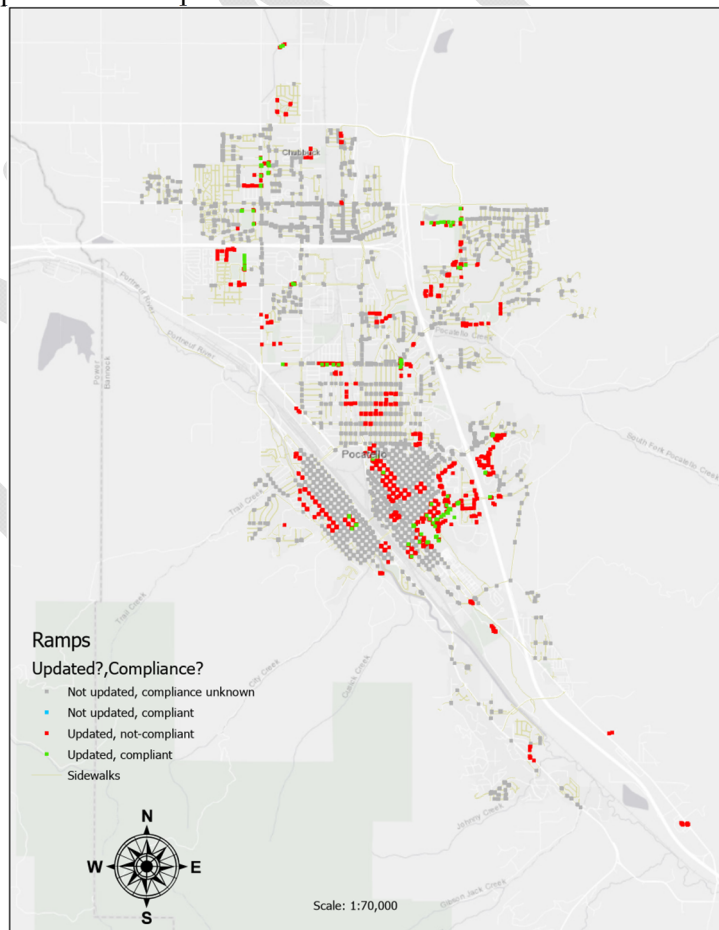
The areas with the highest concentration of compliant and non-compliant ramps are shown in **figure 1**, below. Based on these data the Old Town and in general, southern parts of Pocatello appear to have the highest concentration of non-compliant curb ramps.

Figure 1. Areas with compliant/non-compliant curb ramps based upon summer 2021 field collection
