Report of Summer 2022 Curb Ramp Field Data Collection

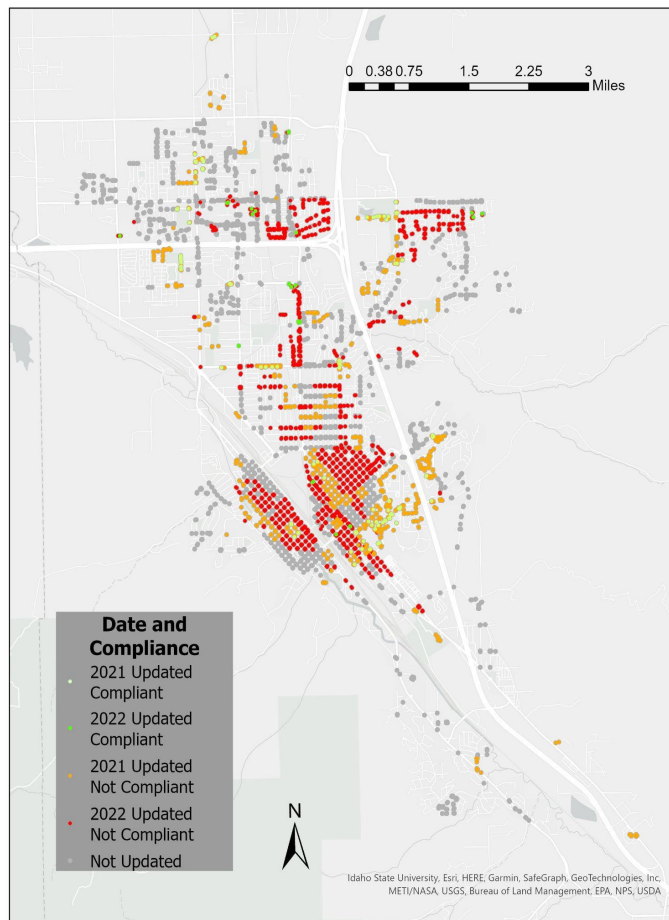
The areas with the highest concentration of compliant and non-compliant ramps are shown in **Map 1**, below. Based on these data the Old Town and southern parts of Pocatello (excluding the university area) appear to have the highest concentration of non-compliant curb ramps.

Map 1. Areas with compliant/non-compliant curb ramps based upon 2021-2022 field collection

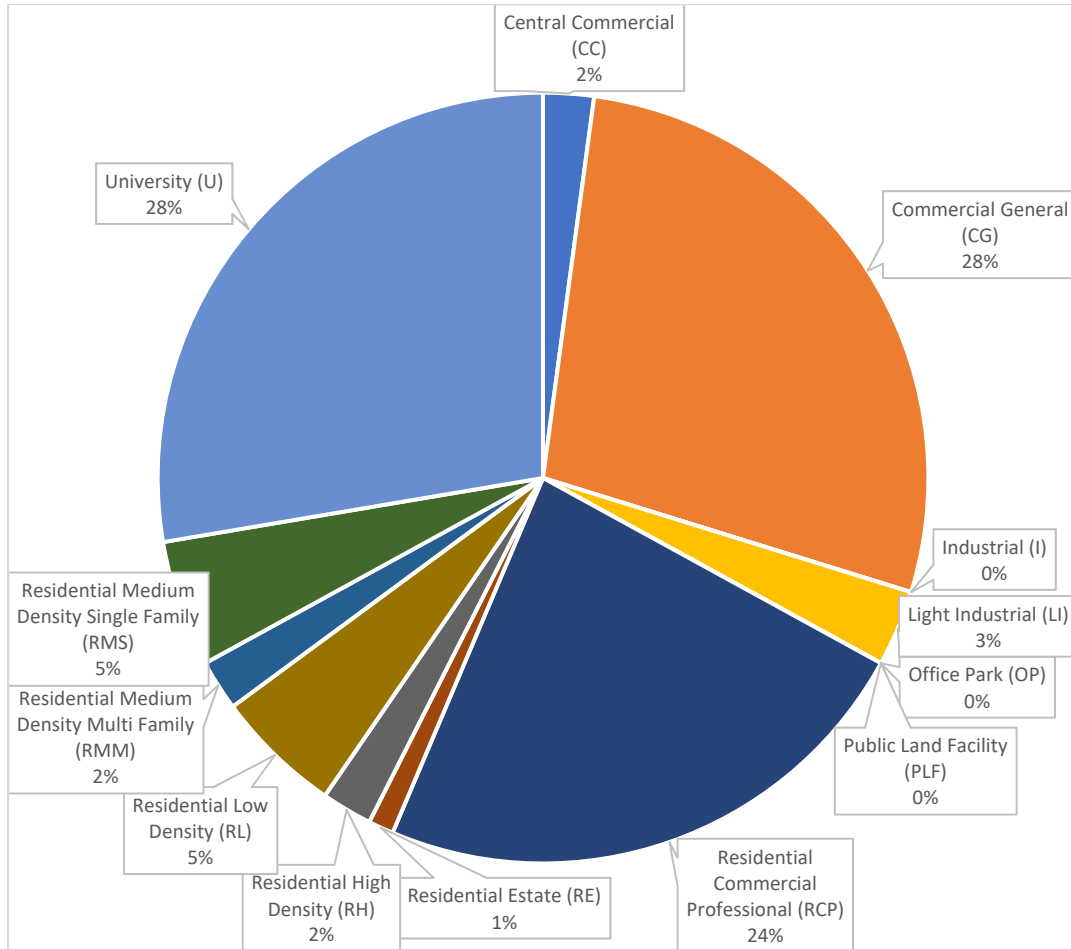
Figure 1. Using only ADA compliant ramps (n = 94), this pie chart summarizes compliance in Pocatello by zoning type using standard values.

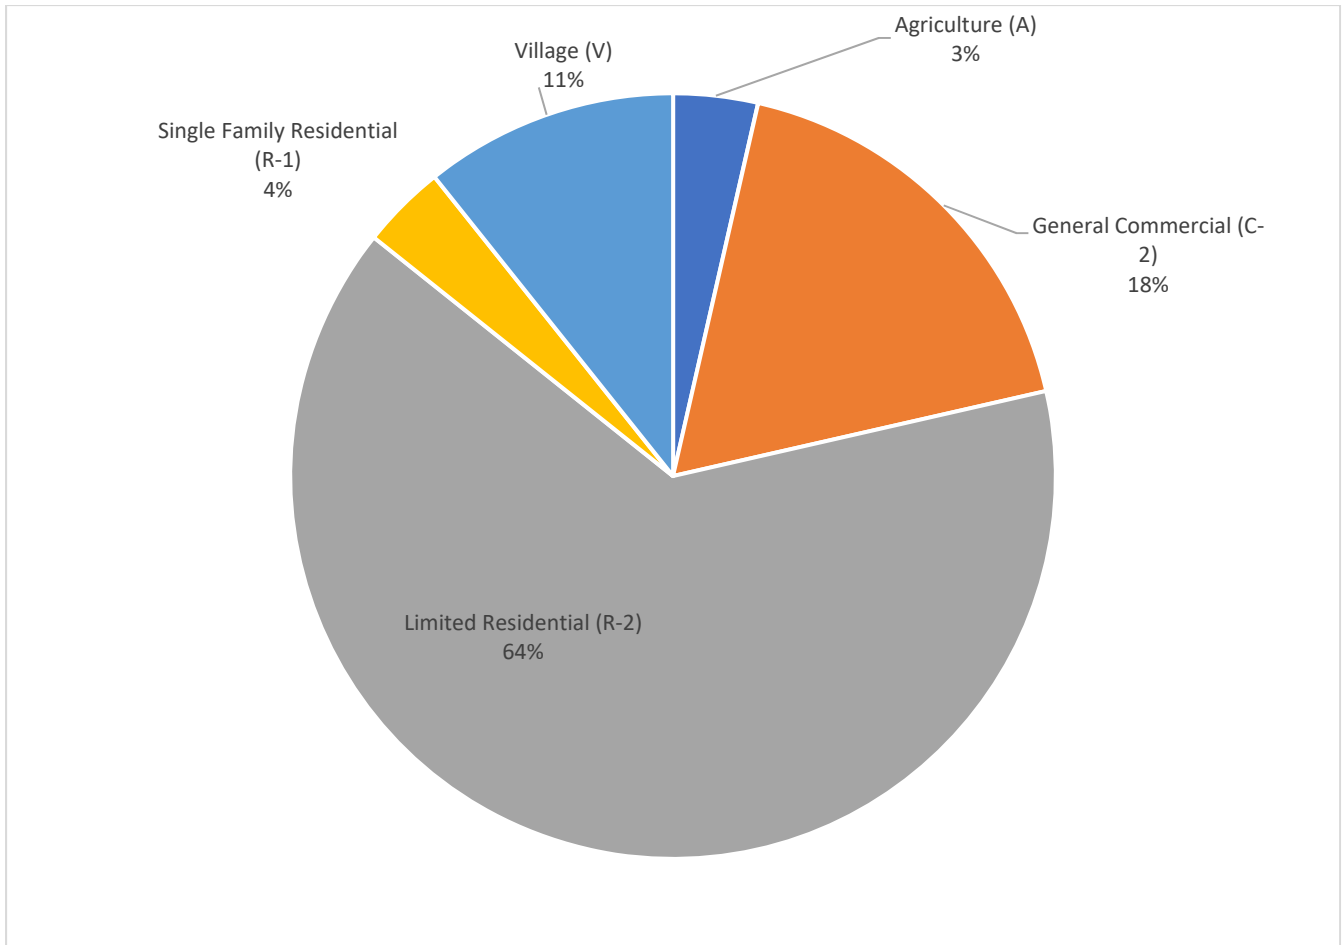
Figure 2. Using only ADA compliant ramps (n = 29), this pie chart summarizes compliance in Chubbuck by zoning type using the standard values.

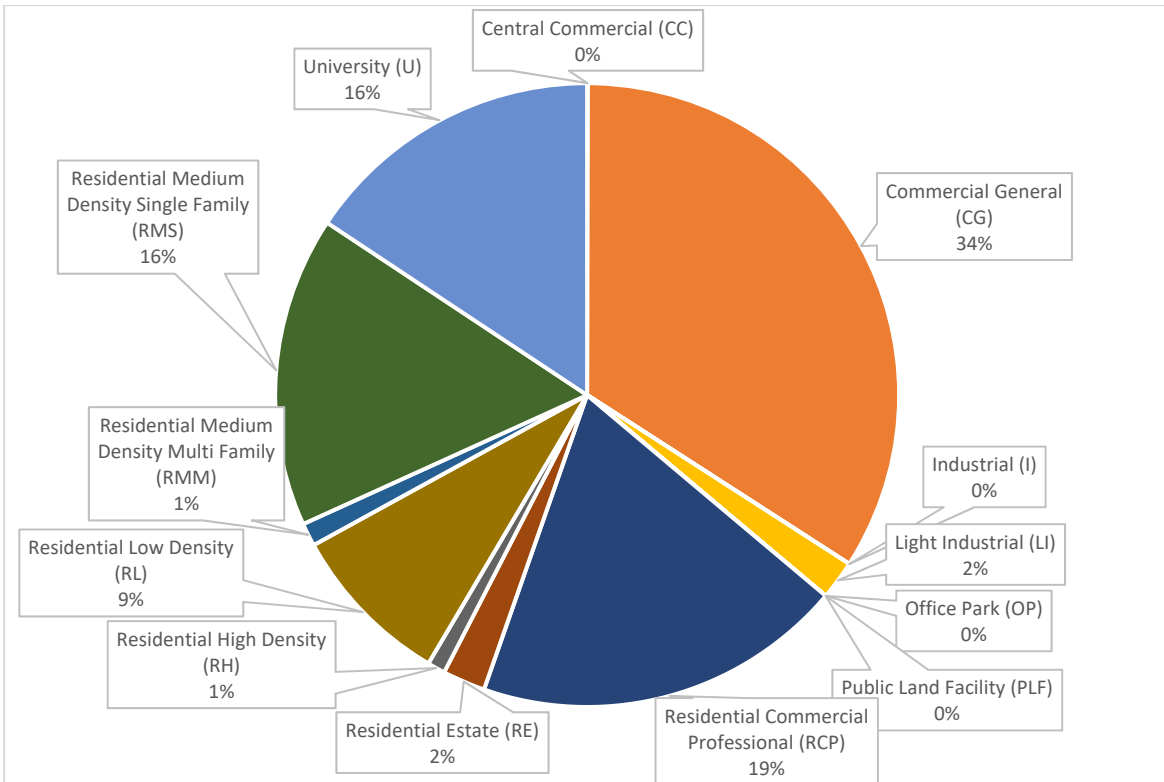
Figure 3. Using only ADA compliant ramps (n = 94), this pie chart summarizes compliance in Pocatello by zoning type weighted by zoning type.

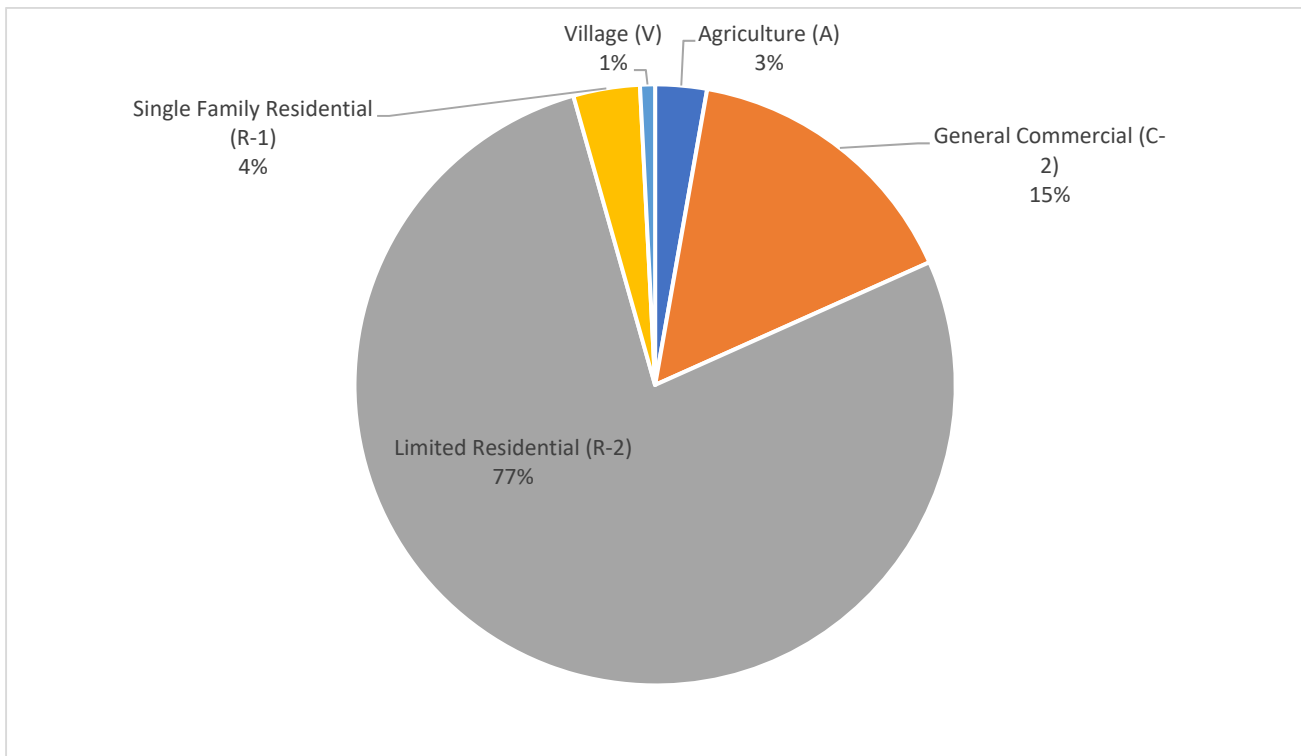
Figure 4 Using only ADA compliant ramps (n = 29), this pie chart summarizes compliance in Chubbuck by zoning type weighted by zoning type.

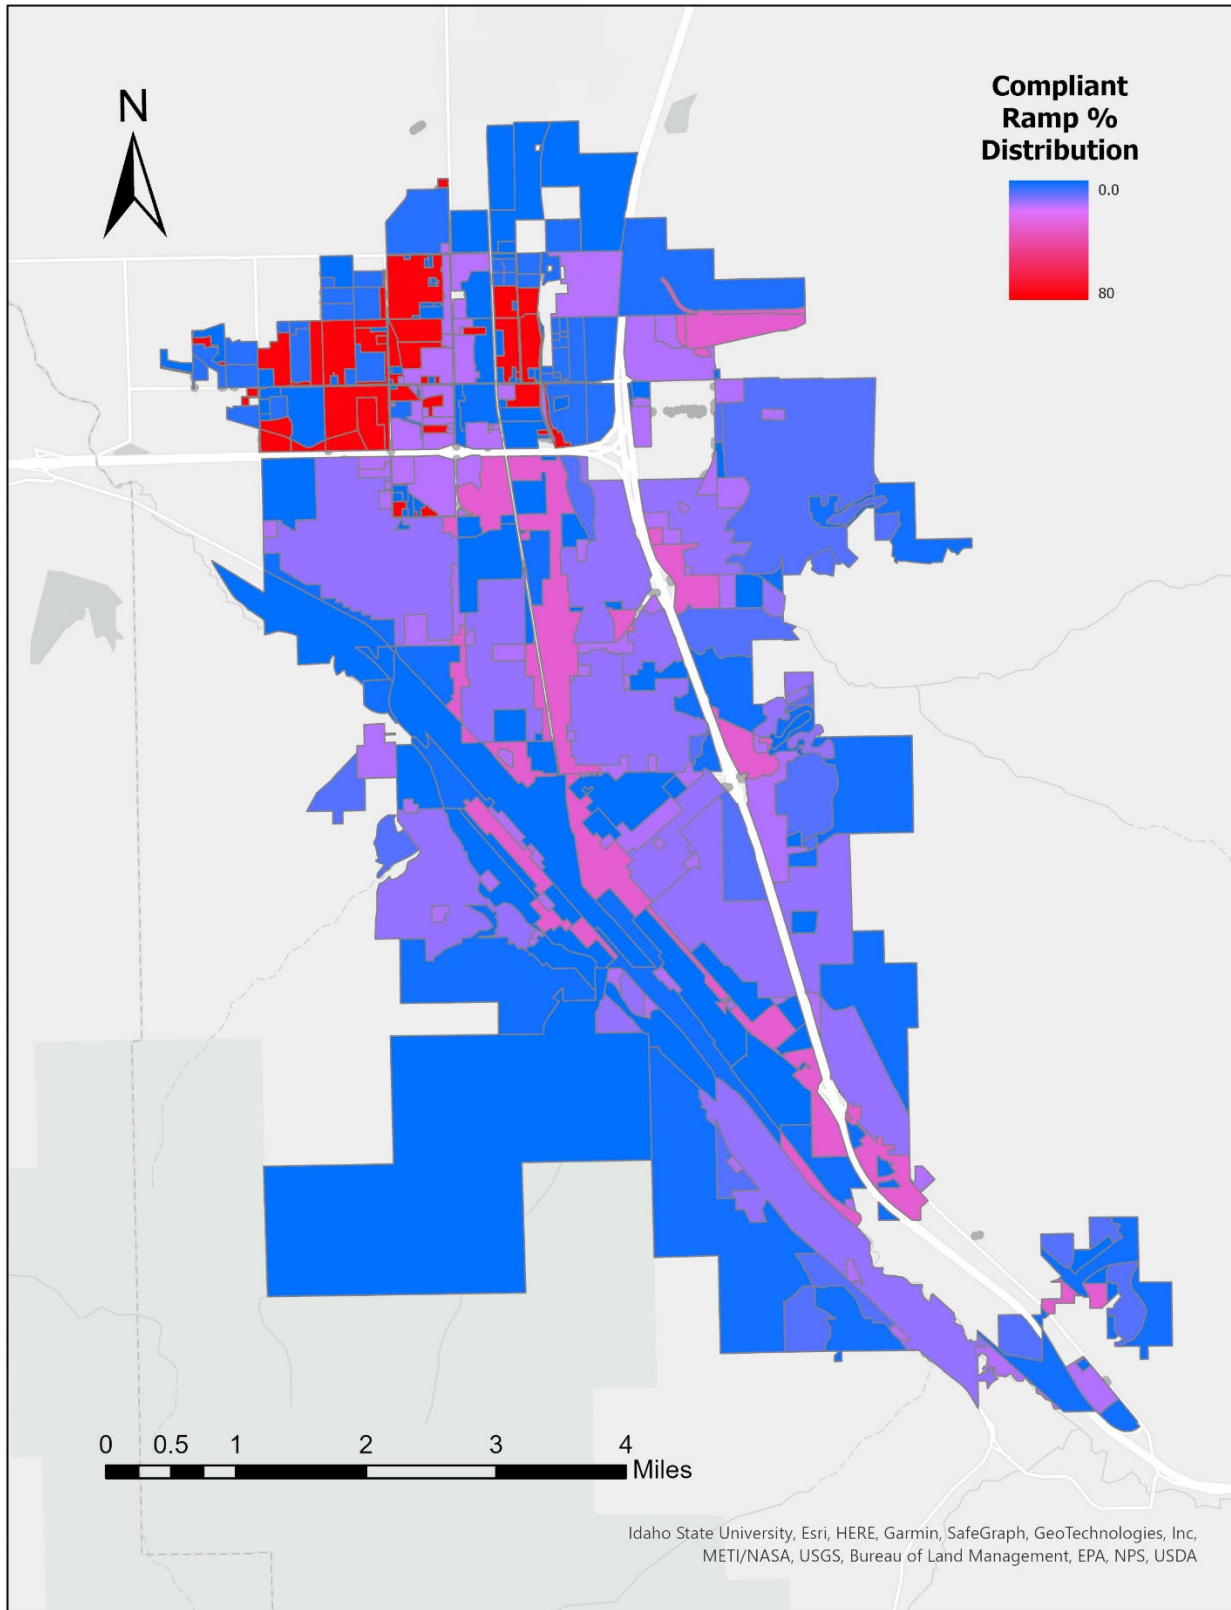
Figure 4. Zoning areas showing distribution of ADA compliant ramps ($n = 137$) using area weighted values.
