2023 CURB RAMP REASSESSMENT

Danielle Huerta, GIS Technician, Idaho State University, GIS Training and Research Center
Keith Weber, GISP, GIS Director, Idaho State University, GIS Training and Research Center

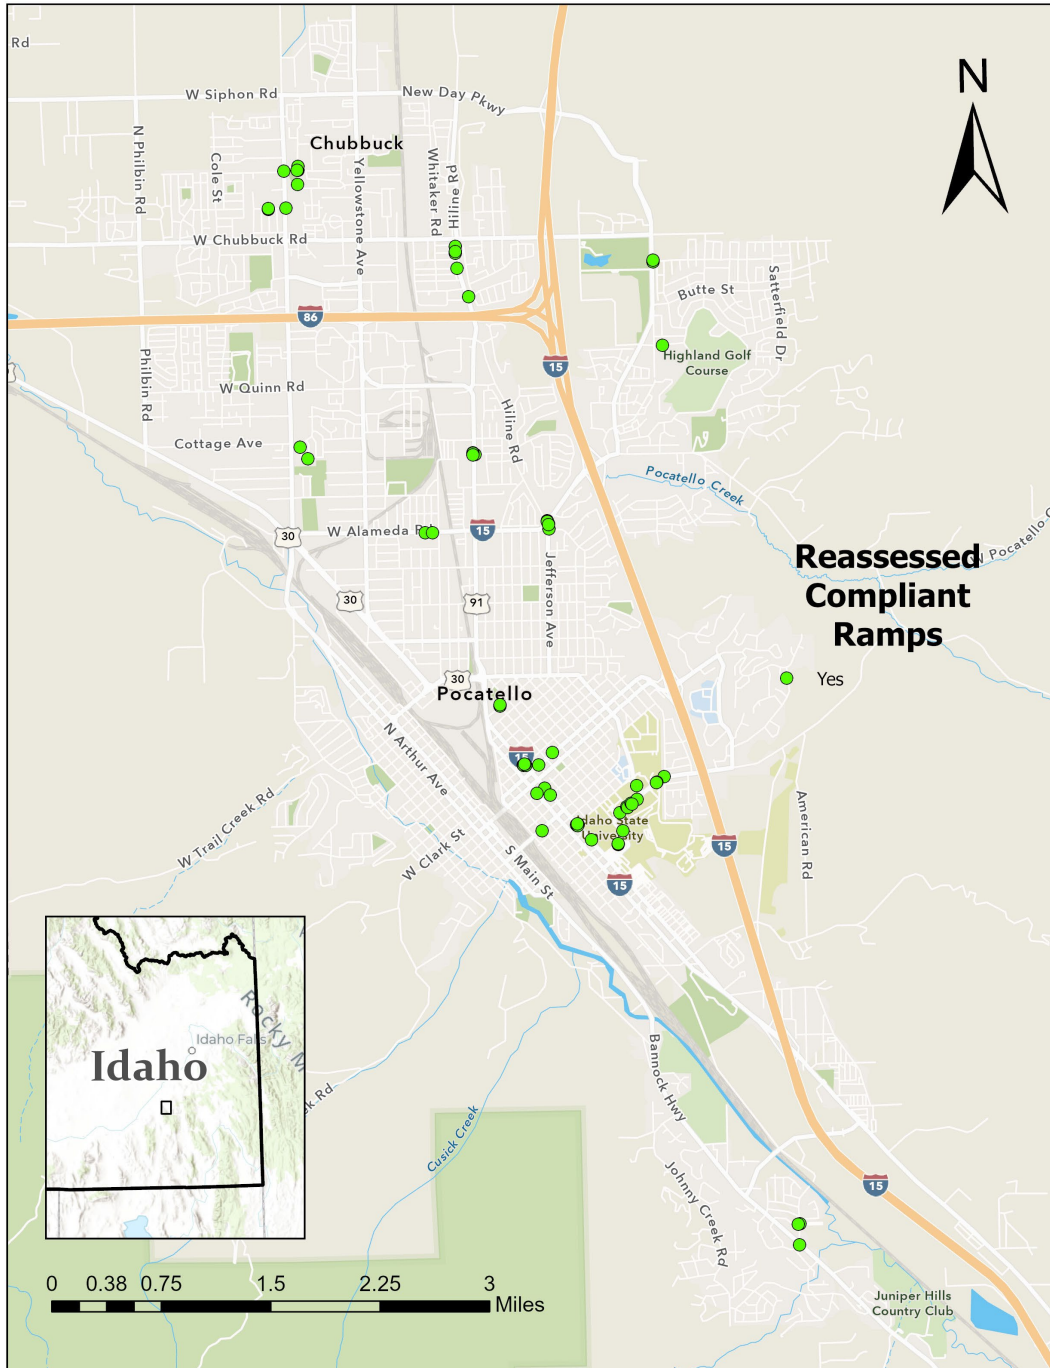
Out of 4,940 ramps in inventory, only 66 were found to be fully compliant based on this reassessment (**Figure 2**). Furthermore, one will see that only 729 ramps have crosswalks present. Ramps that are considered combined constitute a total of 2,831 ramp, or 57% of all ramps in inventory. This leaves 2,109 ramp that are either perpendicular, parallel, or unknown. Even though less than half of the ramps aren't combined, the primary limiting factor was the presence of a crosswalk. Adding a painted

crosswalk to ramps that are not combined and were considered complaint before the new standards were set, these ramps would be considered.

Figure 2 Ramp compliance based on reassessment.

Painting crosswalk designations may sound like a simple remedy to increase compliance. However, this is likely very costly (materials and labor) and would require continued maintenance by the cities.
