TECHNICAL REPORT: 2023 CURB RAMP FIELD DATA COLLECTION

Danielle Huerta, GIS Technician, Idaho State University, GIS Training and Research Center
Keith Weber, GISP, GIS Director, Idaho State University, GIS Training and Research Center

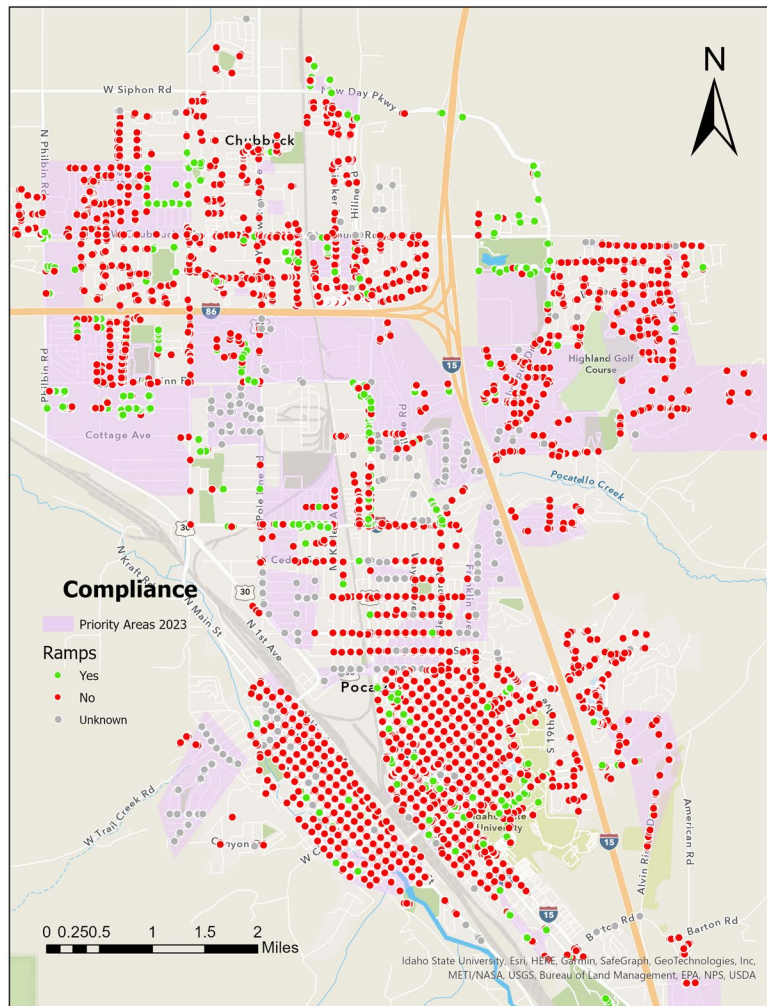
Reevaluation was done using SQL Statement 2, 2010 ADA standards with null values assumed to be compliant. The results for all ramps indicated 643 compliant ramps (13.0%). Using only those ramps evaluated in 2023, 235 were compliant (19.3%).

Figure 1 Compliance of sidewalk ramps in Pocatello and Chubbuck based upon SQL Statement 2, 2010 ADA standards with null values assumed to be compliant.

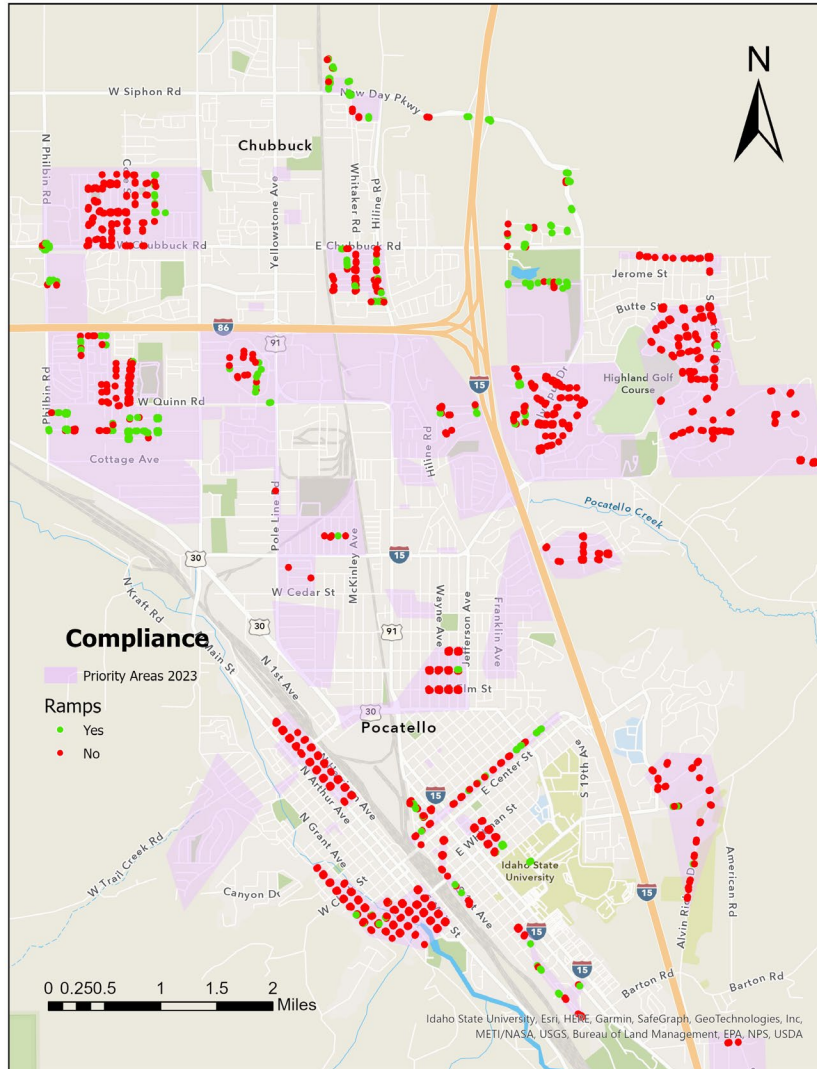
Figure 2 Compliance of sidewalk ramps evaluated during the summer of 2023 in Pocatello and Chubbuck, Idaho based upon SQL Statement 2, 2010 ADA standards with null values assumed to be compliant.
