THE USE OF REMOTE SENSING IMAGERY FOR EVALUATION OF POST-WILDFIRE SUSCEPTIBILITY TO LANDSLIDE AND EROSION HAZARDS IN THE SALMON-CHALLIS NATIONAL FOREST, LEMHI COUNTY, IDAHO

Diane K. Sprague-Wheeler
Department of Geosciences
Idaho State University
Pocatello, ID 83209-8130

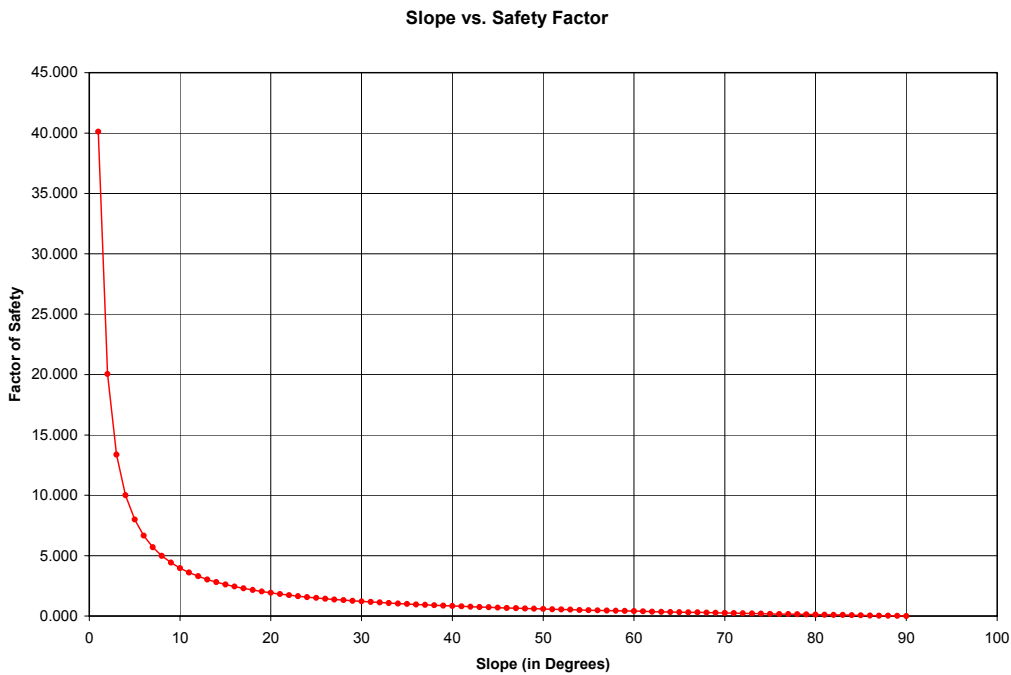
Figure 5. The relationship between slopes and Safety Factors (SF) in dry, cohesionless soils with a friction angle of 35°. Slopes with a SF greater than 1 indicate stable slopes, and values below 1 indicate a slope is prone to failure.

Shear stress and shear strength were not measured quantitatively in the field; therefore, slope rankings for the landslide hazard classification system were determined by calculating the Factor of Safety for slopes in the study areas between 0-90° (Figure 5, Table 5). Soils in the field areas are generally dry, and saturation values are assumed to be zero for this study. Soils are predominantly cohesionless and cohesion is expected to play a smaller role than the friction angle, thus cohesion values are assumed to be zero for this study. A friction angle of 35° was assumed to be representative of the soil types (mostly sandy) in the field areas.

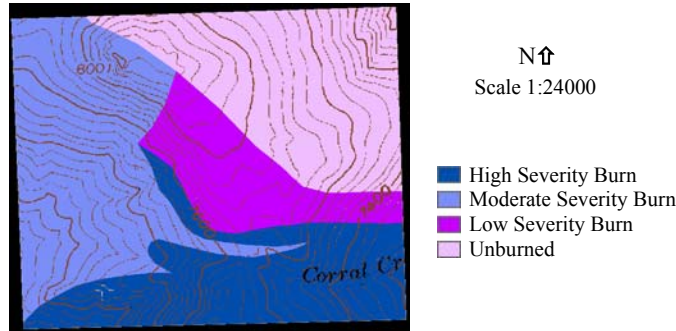
Figure 18. Burn severities of Site #2. (Base map from USGS Duck Creek Point 7.5 Minute Quadrangle.)

The burn intensities of Site #2 include all degrees of severity (Figure 18). High severity burns, ranked with a value of 10 for this study, cover 25% of the total site area. Moderate severity burns were ranked with a value of 9 and cover 32% of the site. Low severity burns were ranked with a value of 8 and cover 14% of the site. Unburned areas cover 29% of the site area and were ranked with a value of zero.

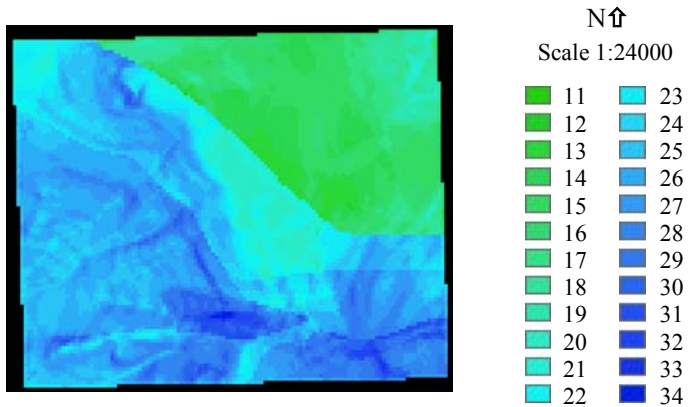
Figure 24. Relative erosion hazard for Site #2. Areas relatively more likely to experience erosion have higher values. (Derived from USGS Duck Creek Point DEM, 10-m resolution).

The relative hazard map for erosion incorporates the parameters of slope, aspect, burn severity, understory vegetation cover, hydrology, bedrock geology, and soil characteristics. The relative values for erosion hazard range between 11-34, with 11 being relatively less likely to experience erosion and 34 being more likely (Figure 24). The highest values occur in the southern and northwestern portions of the site.

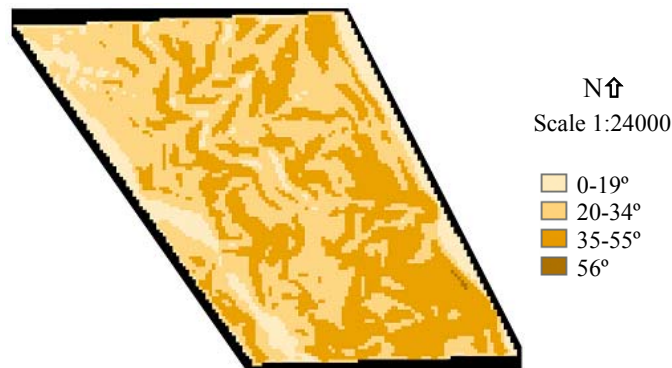
Figure 25. Slopes of Site #3. (Derived from USGS Yellowjacket DEM, 10-m resolution).

Slopes range from 0-56° (Figure 25) and the predominant aspect is eastern (Figure 26).

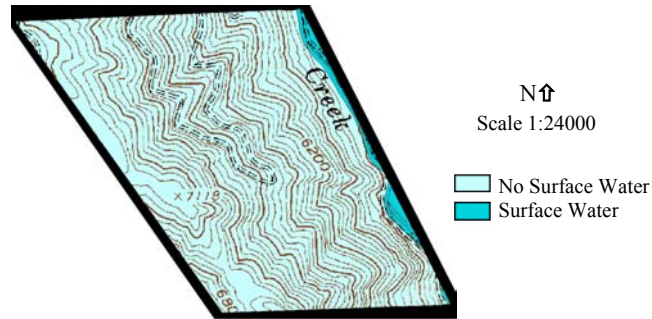
Figure 29. Hydrology of Site #3. (Base map from USGS Yellowjacket 7.5 Minute Quadrangle).

A large percentage of this site, 98%, contains no surface water (Figure 29). These areas were ranked with a value of zero. Only 2% of the site has surface water, which is in the form of a stream (Lake Creek) along the eastern perimeter of the site, and was ranked with a value of 10.

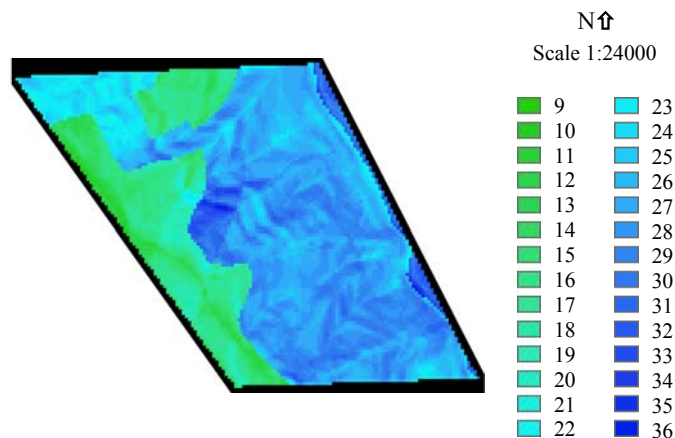
Figure 33. Relative erosion hazard for Site #3. Areas relatively more likely to experience erosion have higher values. (Derived from USGS Yellowjacket DEM, 10-m resolution).

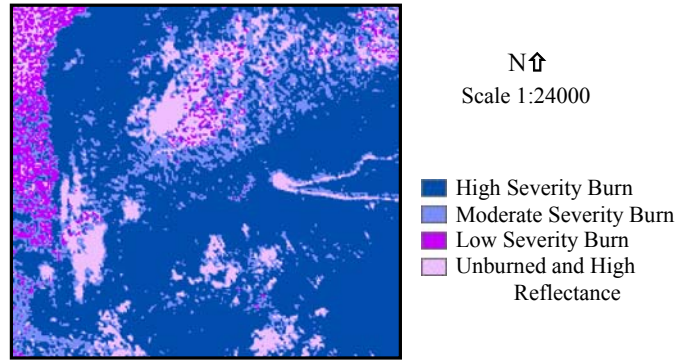
Figure 34. Burn severity of Site #1 assessed with a minimum distance algorithm. Areas of high reflectance include rock outcrops and roads. (Derived from IKONOS imagery, 4-m resolution).

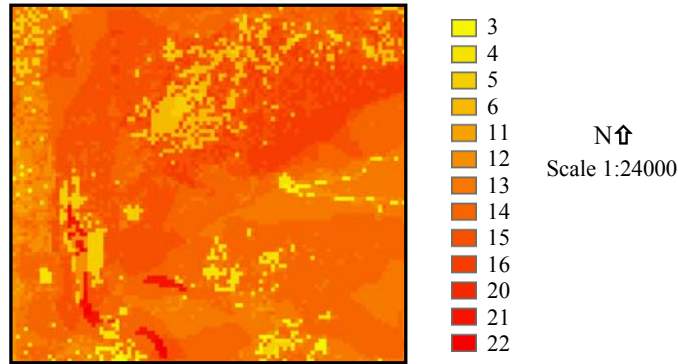
Figure 36. Relative landslide hazard for Site #1. Areas relatively more likely to experience landslides have higher values. (Derived from USGS Blackbird Mountain DEM, 10-m resolution, and IKONOS imagery, 4-m resolution).

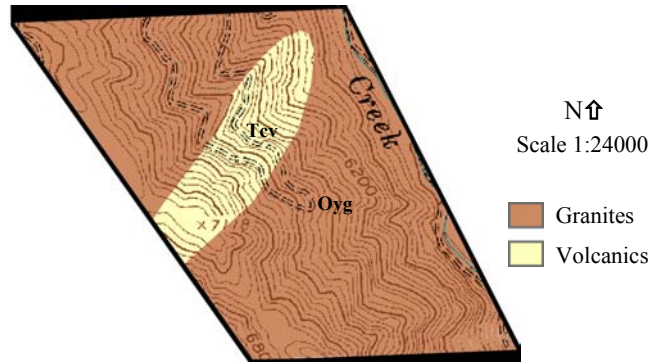
Figure 44. Geology of Site #3. The bedrock of this site is primarily coarse-grained granodiorite (Oyg). A ridge at the western portion of the site is intruded by northeast-trending dikes of quartz porphyry intrusions (Tcv). No attitudes available on source map.
